V. ROADS AND UTILITIES

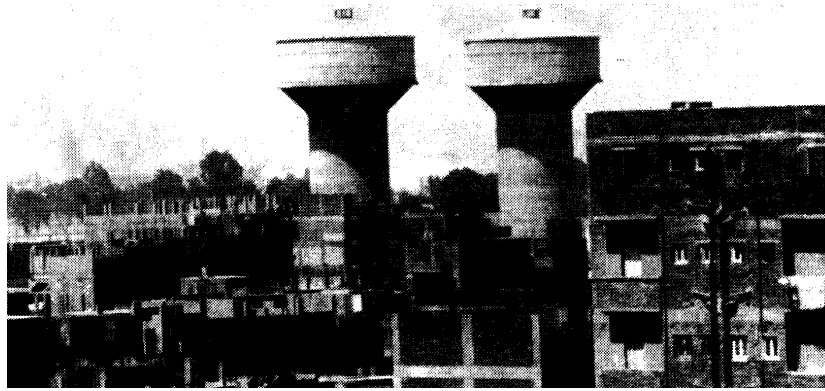
Photo 5.1 Water towers built along north edge of project

USAID has participated in the implementation of the first stage of the water-supply project that included the creation of two main sources of water (two elevated water towers in the project area with a capacity of 2000m³/day). In addition, this stage included the provision of main streets with potable water network reaching a total length of 8.3 km. The first stage started in 1982 and was completed in 1984. The USAID provided US\$ 1,710,000 and Government of Egypt (GOE) provided £E 1,643,000 (US\$ 2,347,143) for this stage.

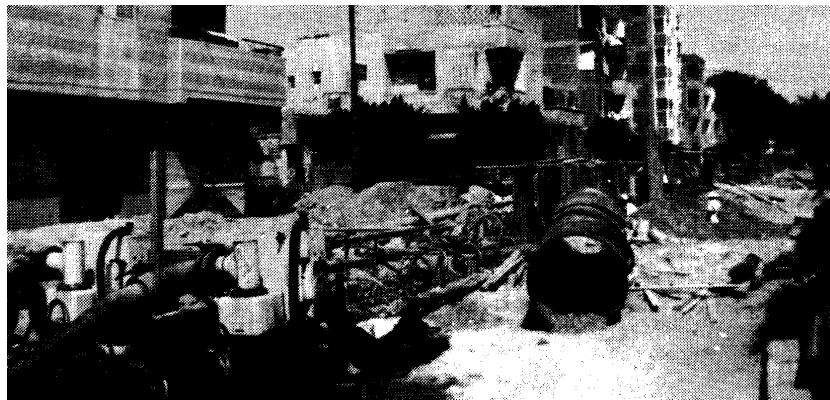
Photo 5.2 Upgrading – installing main sewerage network

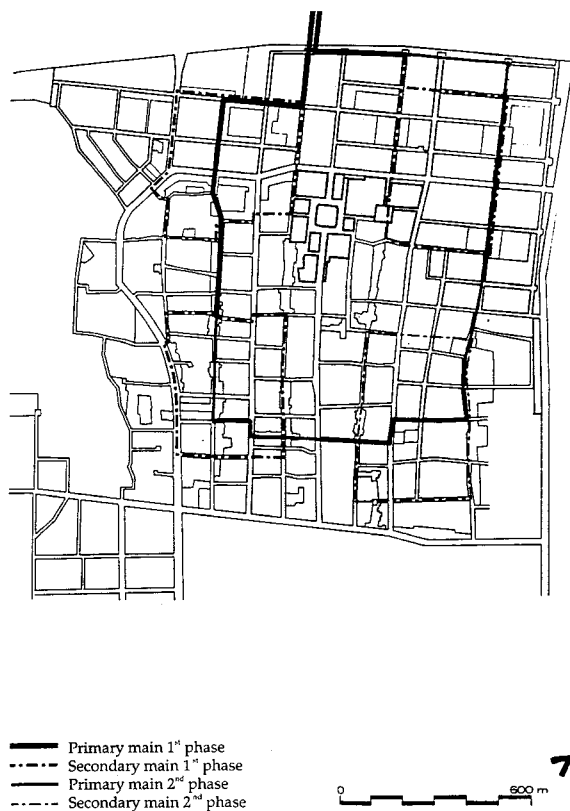
Figure 5.4 Phasing of Hai El Salam water
 Source: Arab Republic of Egypt, 1978: vol.1.

The proposed water distribution network (see figure 5.3) consists of a primary ringmain feeding four secondary ringmains each supplying water to approximately 24,000 people by the year 2000. The implementation was phased incrementally to follow demand (see figure 5.4). Water is supplied to the area by gravity from a storage reservoir, situated some 400 metres north of the project area in the proposed university area.

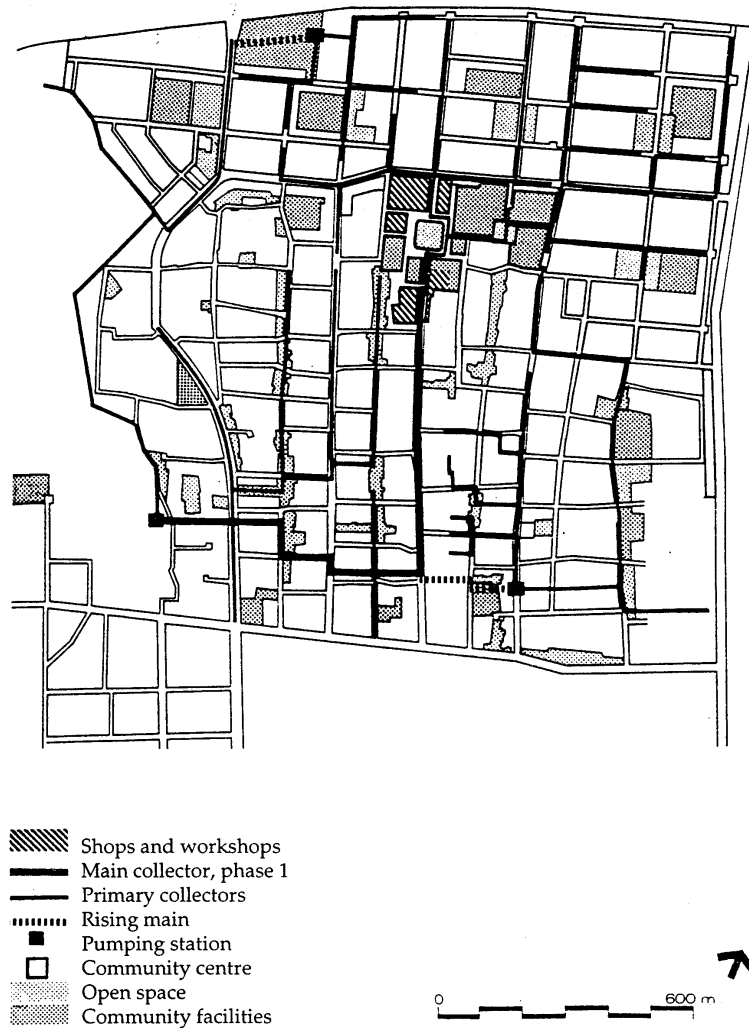
Figure 5.5 Hai El Salaam sewerage
Source: Arab Republic of Egypt, 1978: vol. 1

The proposed sewerage system (see figure 5.5) consists of several groups of branching sewers generally falling from the north-east of the site to a pumping station in the south-west. From this station, the sewage would be pumped to the sewage works in a rising main which bypasses the existing (inadequate) city system. Within the project area, secondary systems would discharge to two pumping stations in order to avoid excessive depths on the main collectors.

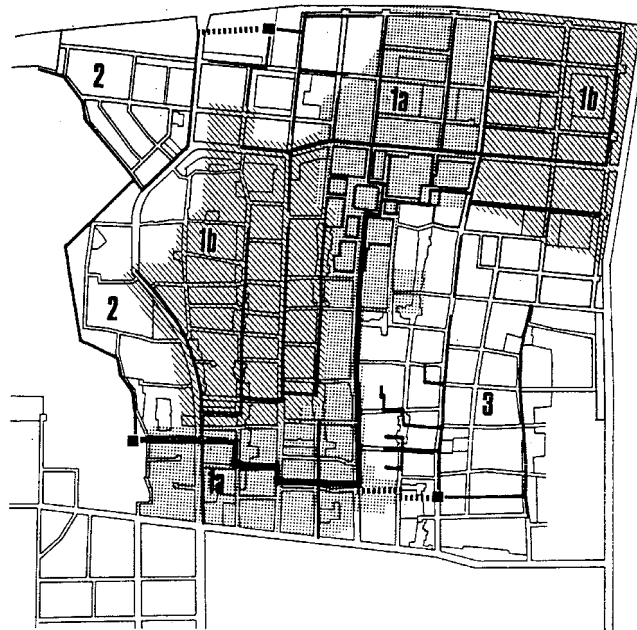
- Phase 1a
- Phase 1b
- Main collector, phase 1
- Primary collectors
- Raising main
- Pumping station

Figure 5.6 Phasing of Hai El Salam Sewerage

Phasing is discussed in more detail below (see figure 5.6). Briefly, proposals for the first phase consisted of the main collector running east from the pumping station, proposed in the master plan, then north up Mustashfa Street to the community centre and Phase 1 of the new development area. Phase 2 would consist of an extension to this system to the north-west corner of the project area and also the west collector running along the edge of the existing built-up area. The south-east system and pumping station would form the final phase. An emergency outfall from this station should discharge to the adjoining groundwater drain. It was proposed that the existing groundwater, or cover drain, should be cleared out and repaired as necessary.

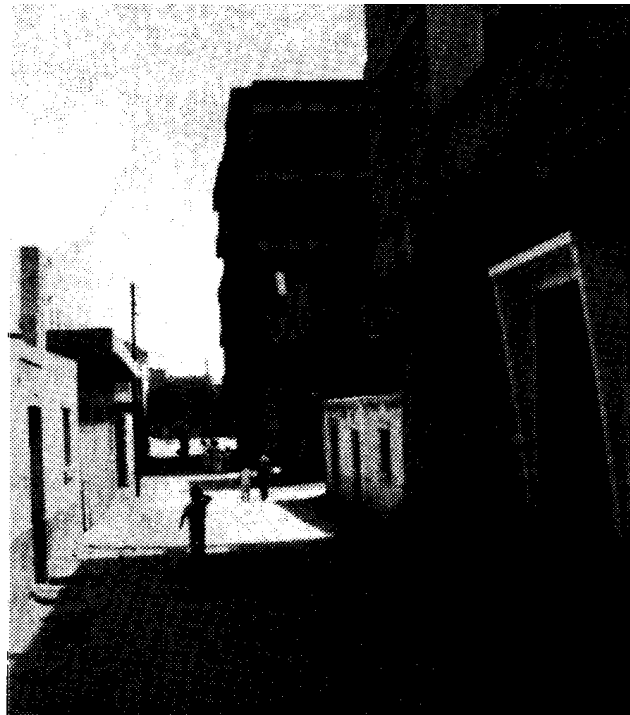
Photo 5.3 Surfaced street before infrastructure installation

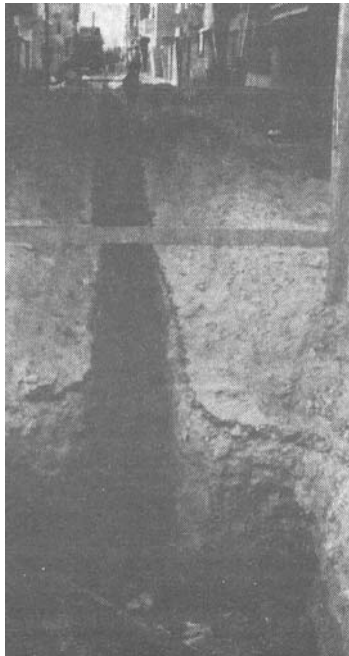
Photo 5.4 Trenches dug for sewerage pipe installation

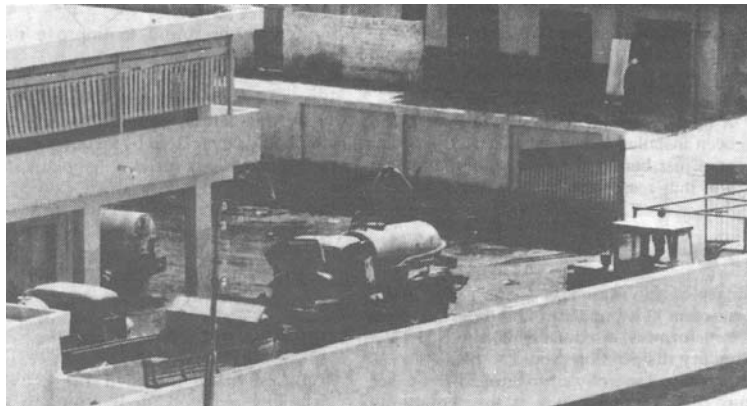
Photo 5.5 Project Agency trucks to evacuate pit latrines

The project provided a fleet of pump trucks to remove sewage from tanks in addition to the procurement of trucks for garbage collection (Project Agency Funds £E 979,258 (1980, US\$ 1,398,940)). The waterborne system has taken much longer to implement than initially estimated. This resulted from technical problems such as the high water table in the southern section of the project site. Delays and inflation have caused several changes of contractors and financing has been adversely affected. The Governorate of Ismailia coordinated with the national organization of potable water and

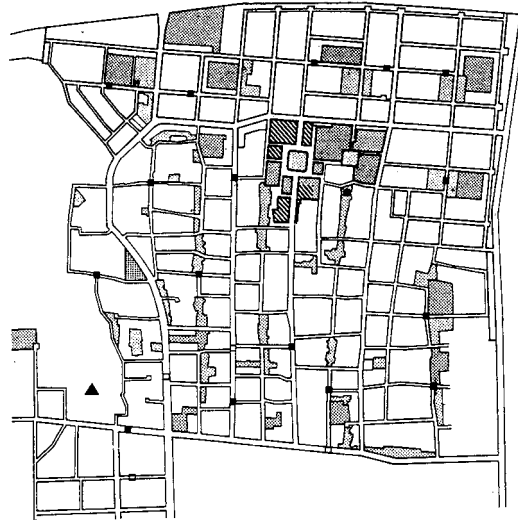
Figure 5.7 Hai El Salam power
Source: Arab Republic of Egypt, 1978: vol. 1

Primary distribution was proposed to be by means of an 11 kV underground cable linking to 18 transformers rated from 200 to 300 kVa. Secondary distribution would be a 380/220 volt supply, generally on overhead lines (see figure 5.7). In areas such as the community centre, the secondary network is would be located underground to improve the visual amenity of the area.
